PRINTCHEK

How it Works

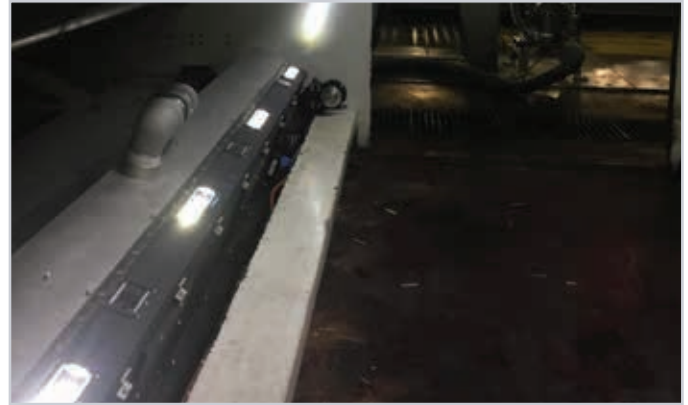
A series of line scan cameras image the entire width of the FlexoFolderGluer or DieCutter to collect a full size image of every fed sheet. Sheet size, rotation and print quality are assessed on each sheet and compared to either a pdf golden standard or a learned golden standard.

- Prior to Die-Cutter
- Empty print section
- Dryer area
- Above or below sheet depending on machine-type

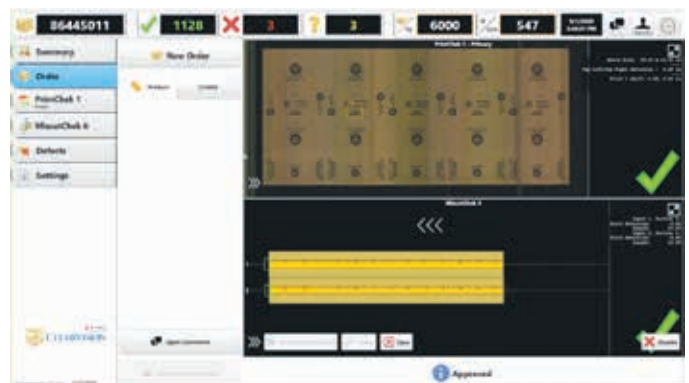
Full Sheet Inspection
